# CITY OF NEW ORLEANS STORMWATER DRAINAGE SYSTEM ROOT CAUSE ANALYSIS FINAL REPORT

Solicitation Number: 2215-02270

ROOT CAUSE ANALYSIS

FINAL REPORT

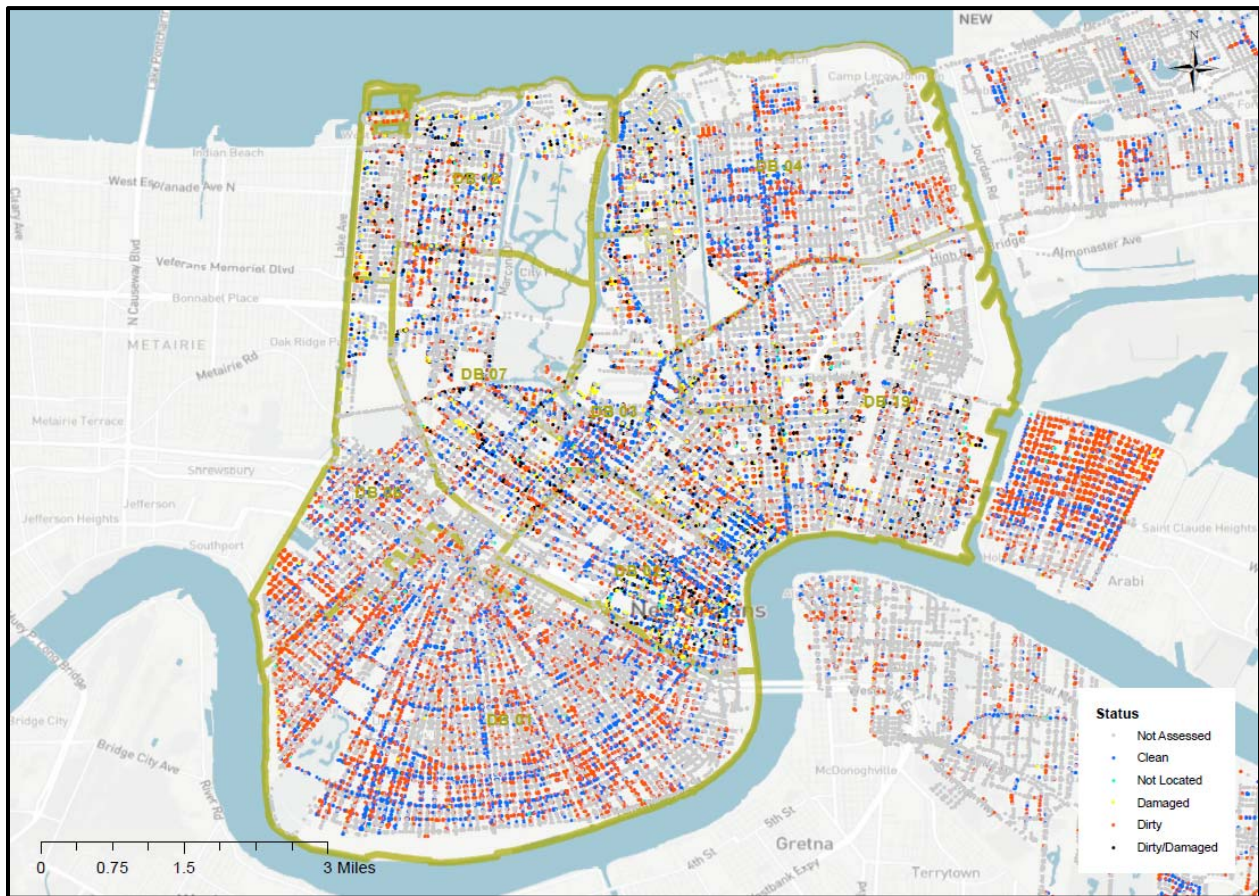
**Figure 7 Catch Basin Condition as of August 5**

Figure 6 indicates distribution of clogged catch basins in the Old City. Figure 7, provided by DPW, shows the condition status of catch basins at the time of flooding on August 5.

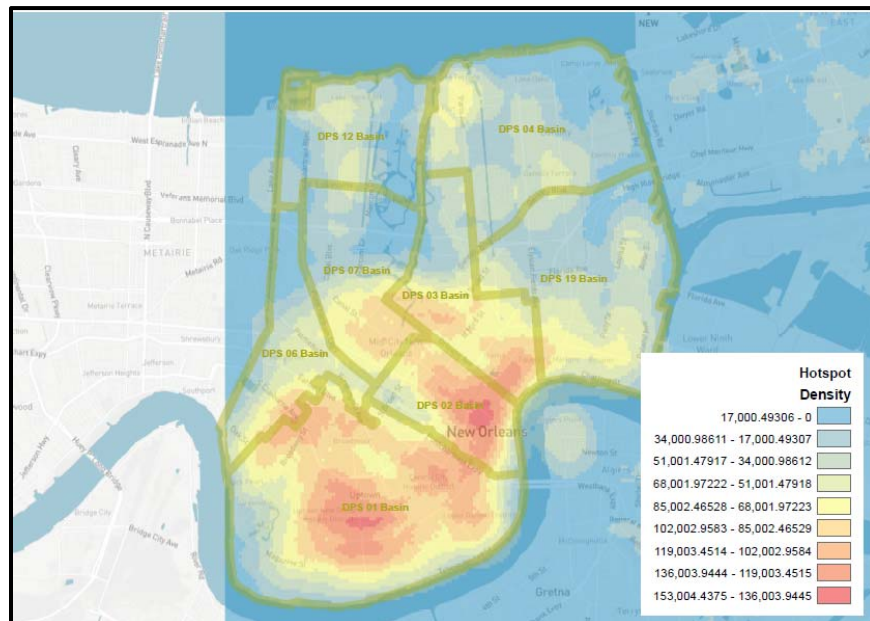
**Figure 9 "Hotspot" Density (<15-in Diameter Pipes) in the Old City**

Figure 8 shows distribution of drainage pipe sizes in the Old City. Figure 9 provides a visualization of small pipe "hot spots" or areas where undersized drainage pipes (less than 15-in diameter) are concentrated. The Veolia Condition Assessment (2017-2018) estimated from a 1 percent sample that the pipe network had 27 percent diminished capacity.

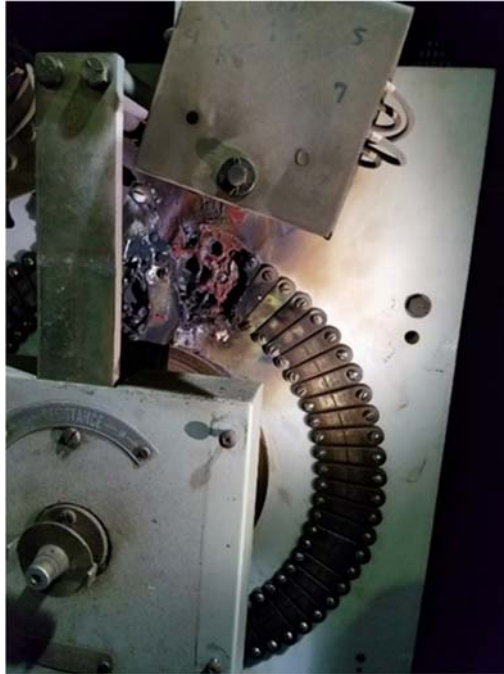
**Figure 16 Damage to Field Rheostat**

The rheostat is located in the cabinet shown in Figure 15. Damage to the field rheostat is shown in Figure 16. Arcing at the contacts of the brushes on the end of the rotating arm resulted in the destruction of brushes, wiring and limit switches. Two areas of the G1- rheostat insulating board were burned at the end of the rheostat arm under the conducting brushes and at the connector strip near the F#1 and F#2 connection points.

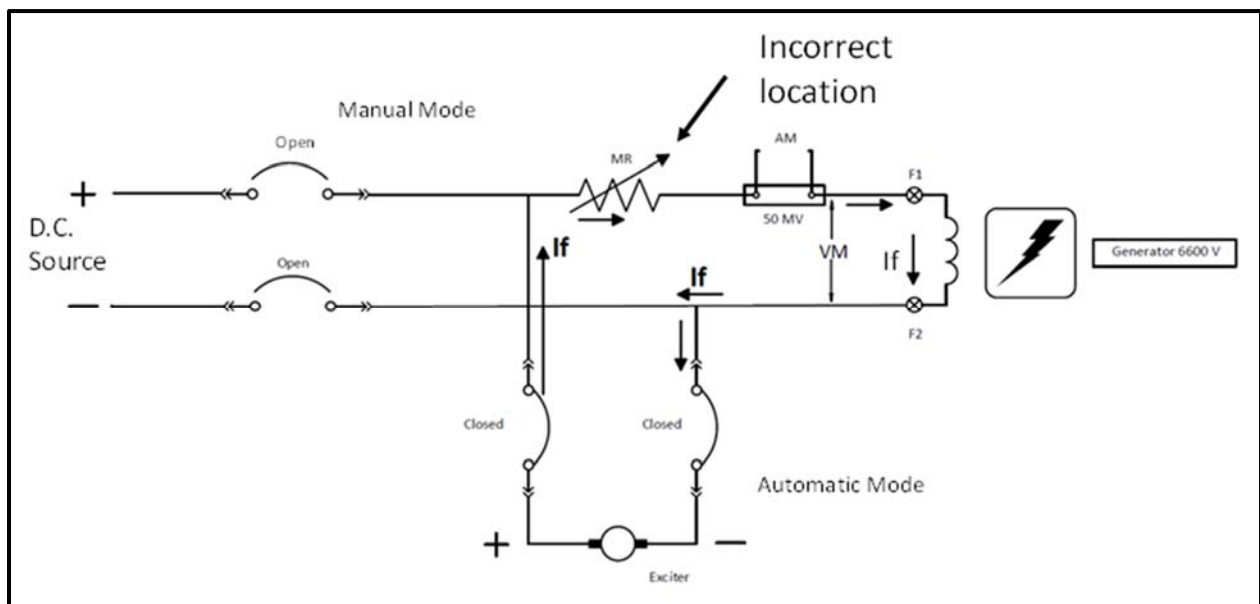
**Figure 18 One Line Diagram With Incorrect Wiring for Field Rheostat**

On May 17, 2018, a contractor from Industrial Electrical Services (IES) examined the rheostat along with S&WB electricians. They discovered that the rheostat had been wired incorrectly. The conductor for the manual mode rheostat was carrying full load current when the field exciter was in the automatic mode. The one-line diagram for the rheostat is shown in Figure 17 . Current would not normally be flowing through the manual rheostat in automatic mode because the breaker is opened and interlocked with the automatic mode breaker. Figure 18 shows the location of the rheostat connection in the mis-wired configuration.

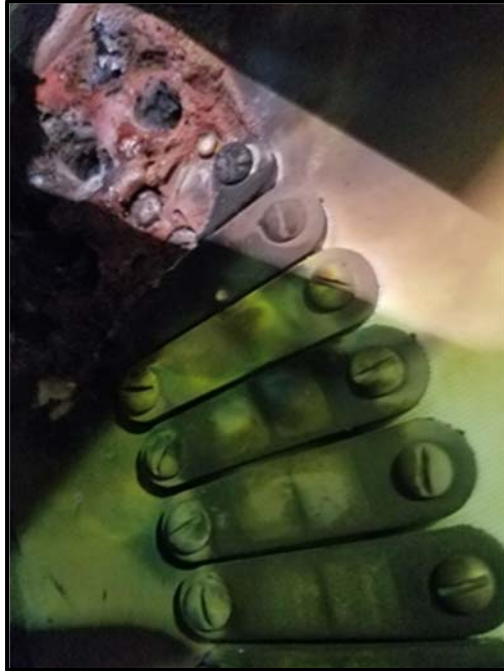
**Figure 19 Field Rheostat Damage August 9, 2017**

operated in both manual and automatic modes. This installation error should not have caused the rheostat to fail. Photos of the damage as from the failure on August 9, seen in Figure 19 show significant arcing at the end of the rotating arm. The arm contains brushes which conduct from the arm to the contact plates.

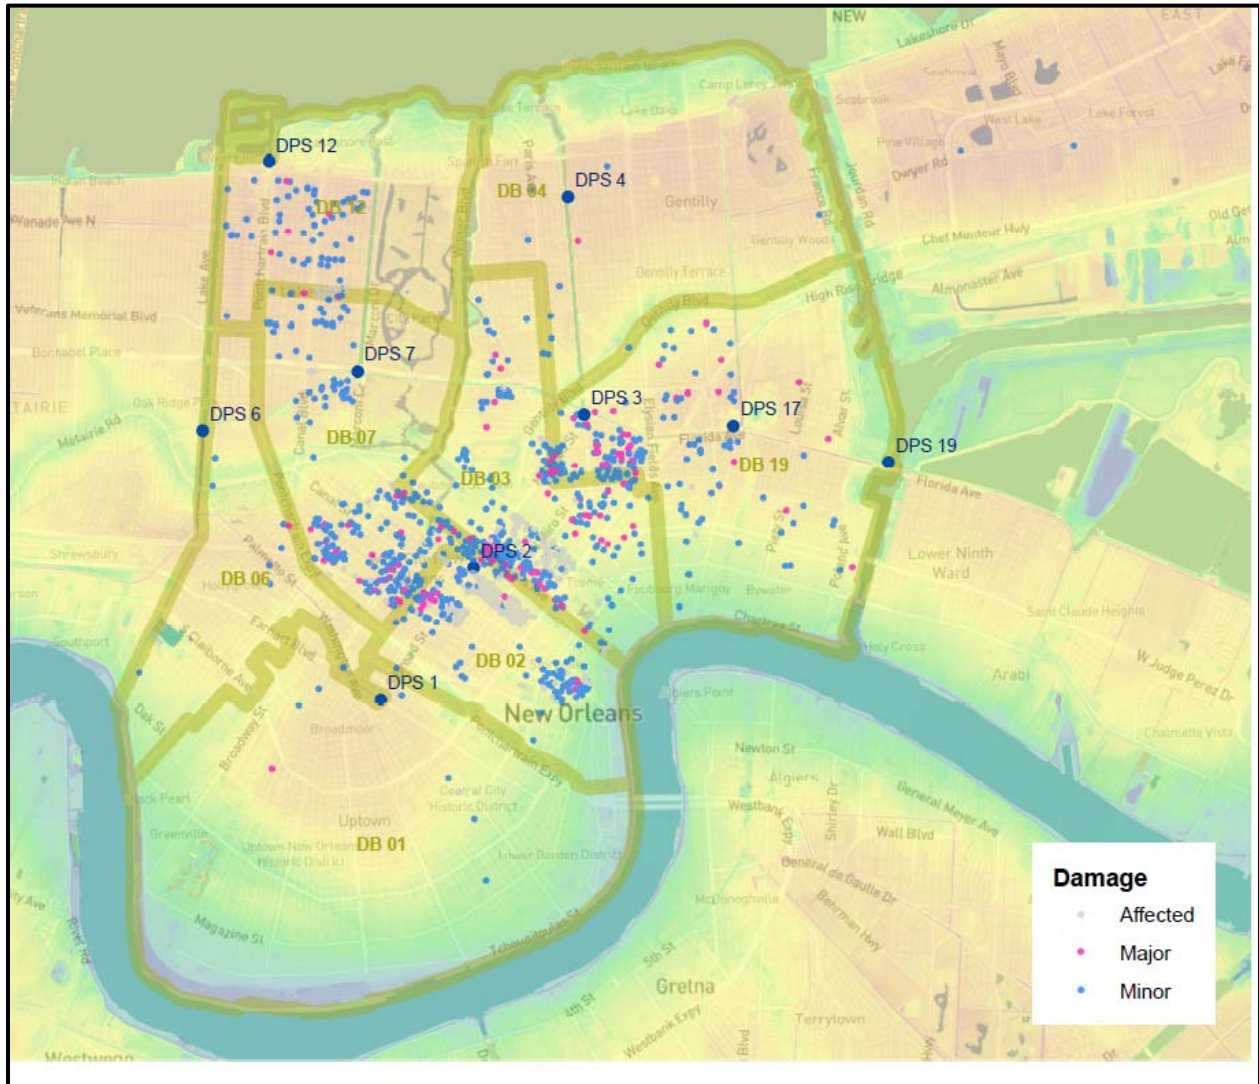
**Figure 24 NOHSEP Flood Damage Assessment August 5 Event**

The NOHSEP damage assessment database indicates there were 151 properties with major damage and 829 properties with minor damage. All drainage basins had at least some damage reports. Mid-City, St. Bernard, City Park, West End and Bywater had reports with major damage. A plot of damage levels is shown in Figure 24.

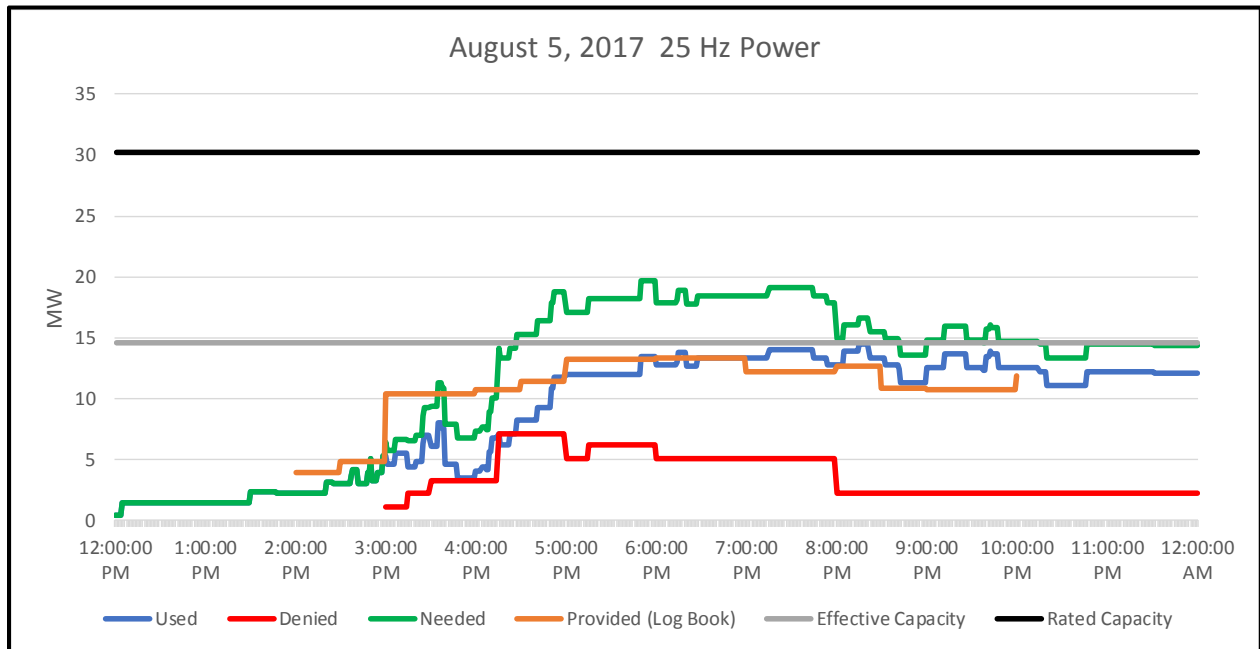
**Figure 31 25 Hz Power Demand vs Capacity**

A similar analysis was prepared by the project team for this report using logbook information for generated power. Computed power used by pumps was also determined based on horsepower and operating status (off, lite, loaded). A time-history of power used, power generated and maximum power available in the system is shown in Figure 30. Figure 31 shows the power used by pumps and the power necessary to supply pumps which were requested but denied along with a total power needed. The denied power was assumed to persist until the log book indicated the pump was started. The analysis indicates the required power exceeded the available power by more than 30%.

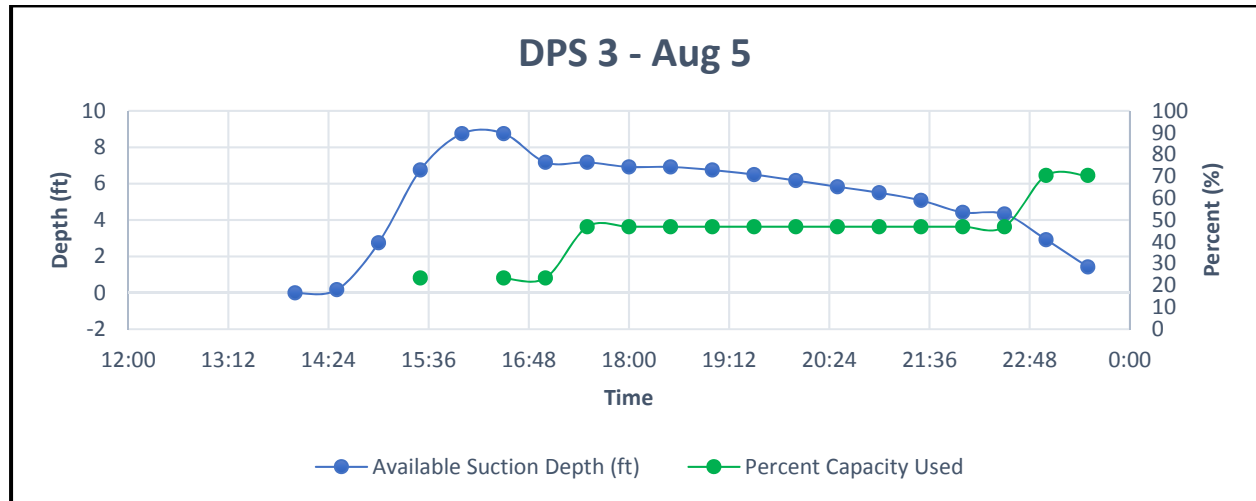
**Conclusion.** Inability of DPS 3 to meet target pumping capacity through critical period of event was due to electrical issues (either system feeder supply problems or station feeder equipment issues). The electrical issues and difficulty in stopping pumps running in reverse quickly indicate that maintenance and repair were inadequate. While flooding would inevitably have occurred under such severe precipitation conditions, it is likely that flood depth and duration during the event could have been reduced if power supply to DPS 3 had been uninterrupted. It is also likely that flooding depth and duration would have been reduced if DPW drainage network cleaning, maintenance and repair had been accelerated.

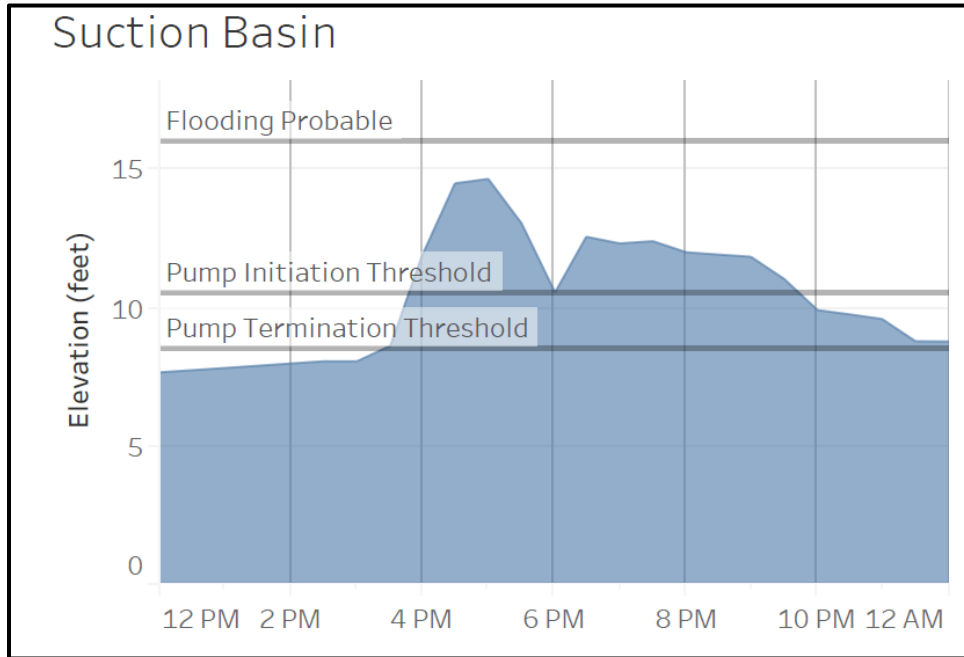
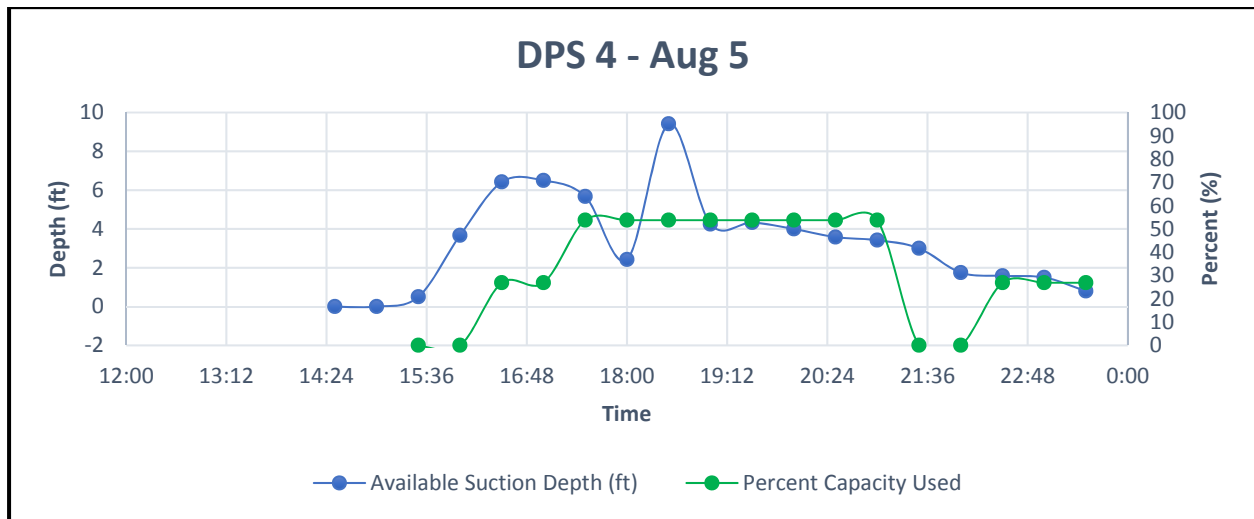
**Conclusion.** Pump power request refusals prevented DPS 4 from attaining target pumping capacity throughout the event. It is likely that flooding during the event could have been reduced if sufficient power had been available to DPS 4 to operate an additional large drainage pump when requested.
