# CITY OF NEW ORLEANS STORMWATER DRAINAGE SYSTEM ROOT CAUSE ANALYSIS FINAL REPORT

Solicitation Number: 2215-02270

ROOT CAUSE ANALYSIS

FINAL REPORT

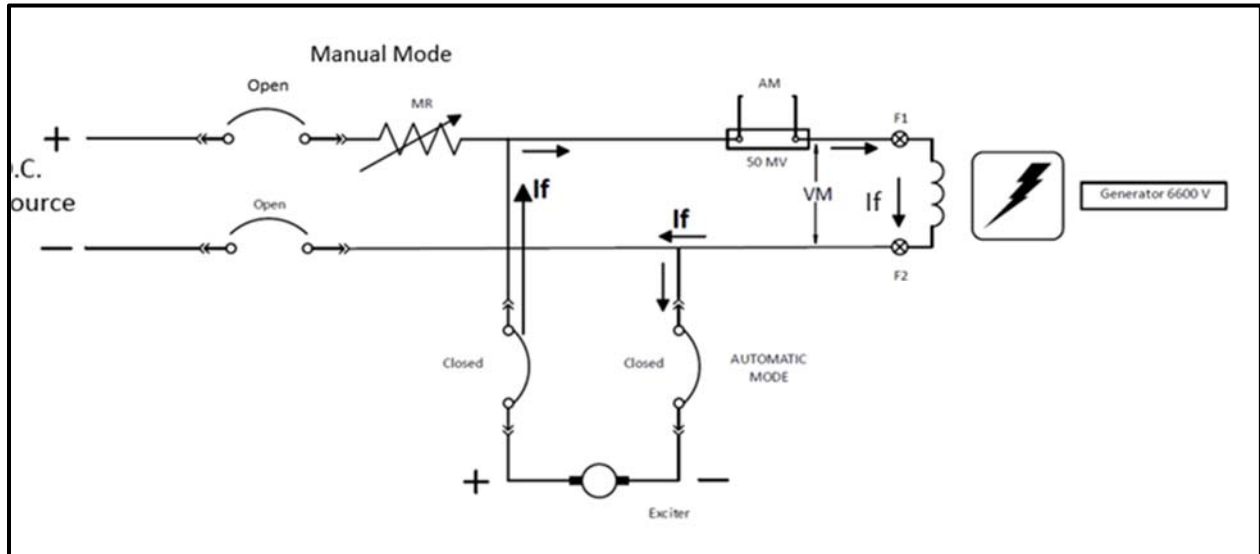
**Figure 17 One-Line Diagram for Field Rheostat**

On May 17, 2018, a contractor from Industrial Electrical Services (IES) examined the rheostat along with S&WB electricians. They discovered that the rheostat had been wired incorrectly. The conductor for the manual mode rheostat was carrying full load current when the field exciter was in the automatic mode. The one-line diagram for the rheostat is shown in Figure 17 . Current would not normally be flowing through the manual rheostat in automatic mode because the breaker is opened and interlocked with the automatic mode breaker. Figure 18 shows the location of the rheostat connection in the mis-wired configuration.

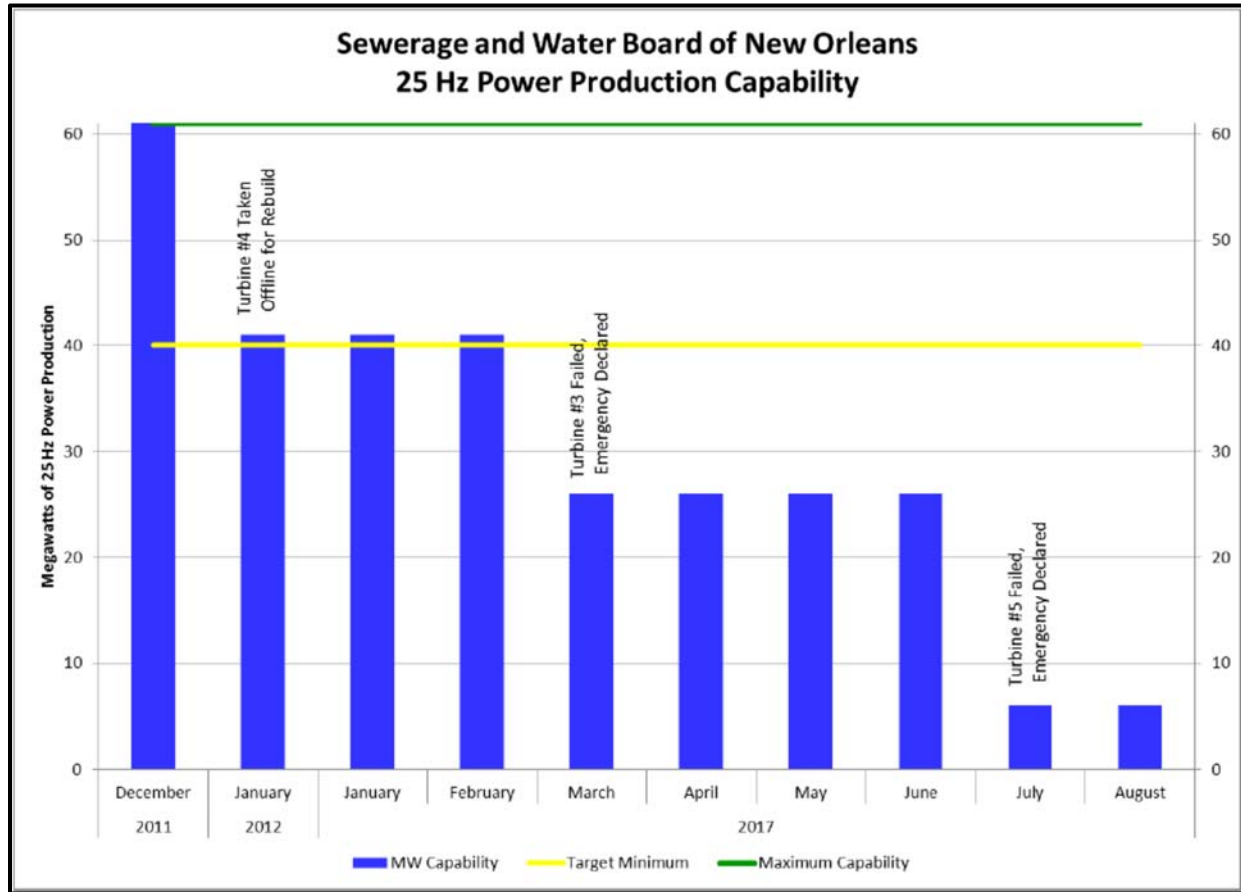
**Figure 29 25 Hz Power Production From S&WB Turbine Generators 2011-2017**

After Katrina, Turbine 4 was the only turbine used to power the drainage pumps. The only option available to power the turbine was dirty steam because the storm destroyed the water cleaning system at the plant so the only steam available was produced by dirty water. Turbine 4 successfully powered the pumps, but the dirty steam critically damaged the turbine to the point that total reconstruction was required. Seven years later in January of 2012, Turbine 4 was removed for reconstruction.

The loss of Turbine 4 reduced the 25 Hz power from the system by 20 MW. This left the system with 41 MW of power. Other turbines had to be utilized more frequently to replace Turbine 4 while it was out of service. Operating condition of the other turbines were not adequate, and the extra utilization proved to be a problem. On March 9, 2017, Turbine 3 failed. This failure reduced the 25 Hz power by 15 MW leaving the system with 26 MW of 25 Hz power. Two days after the July 22, 2017 flood event on July 24, 2017 Turbine 5 failed. This failure reduced the 25 Hz power by 20 MW leaving the system with only Turbine 1 which produces a maximum of 6 MW of 25 Hz power. Turbine 1 was the only generator in working condition leading up to and during the August 5, 2017 event. Figure 29 is a graph created by Ch2M for an S&WB presentation on September 1, 2017 showing the change in available in power as each turbine went out of service.

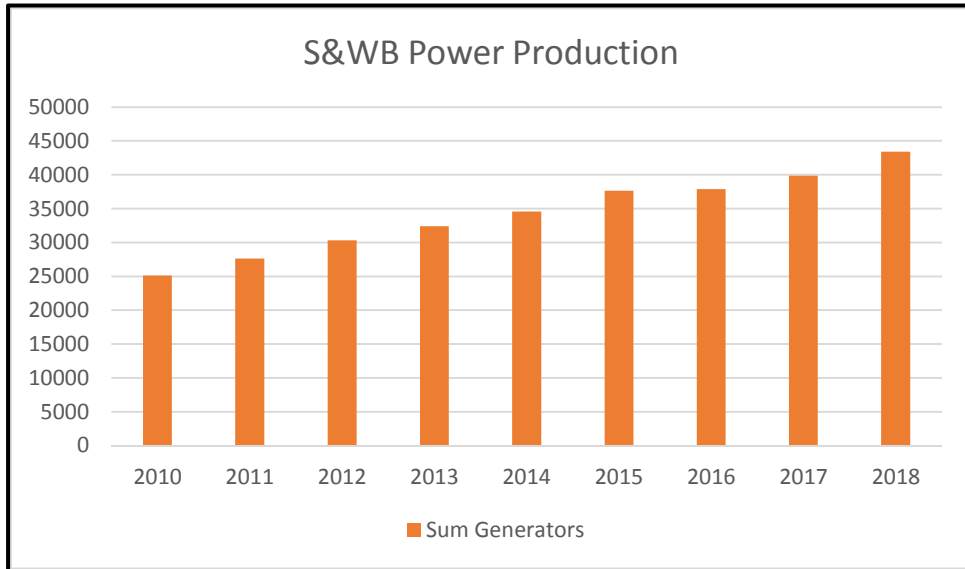
**Figure 32 Power Production by S&WB Turbine Generators(kWH)**

To assess evidence that S&WB made a policy change to use internally generated power to avoid Entergy power interruption, the power usage by S&WB drainage was evaluated and compared to power generated by the turbine generators. In Figure 32, the internal power production increased at a rate of 7-10% per year. Power purchase trends are shown in Figure 33. No clear trend is evident with regard to energy purchases. This data provides some indication of an increased reliance on internally produced power.

There is no evidence that S&WB leadership concurrently evaluated the impact of the increased use of these turbines on their overall functionality nor is there any evidence that provision was made for increased maintenance funding to minimize periods of power unreliability among these assets.

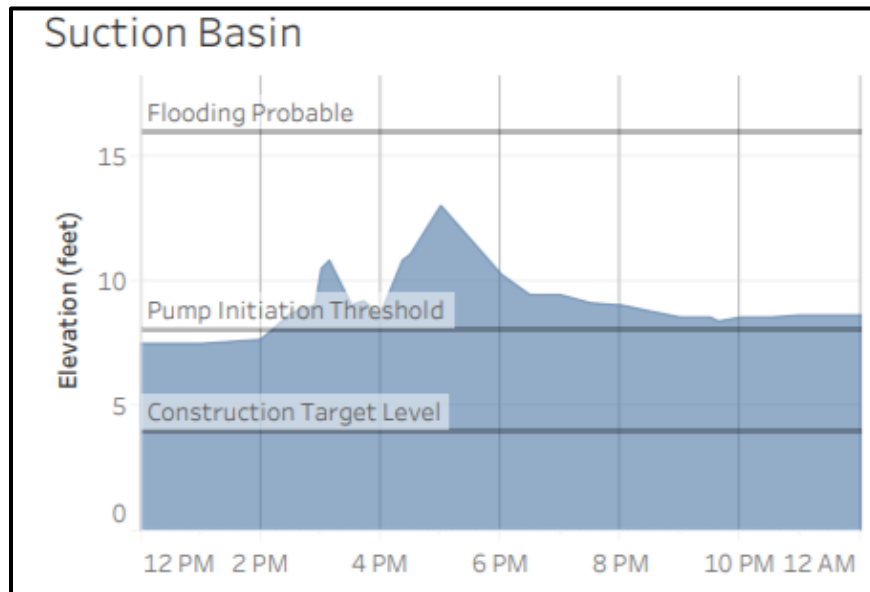
**Figure 37 DPS 1 Suction Basin Levels August 5**

**Conclusion.** The drainage basin experienced much less intense rainfall than other drainage basins. DPS1 exhibited capacity capable of providing an adequate LOS within its drainage basin during the event, with the result that there was little flooding in DB 1. Evaluation of the suction basin levels confirms that minimal flooding would be expected as shown in Figure 37.

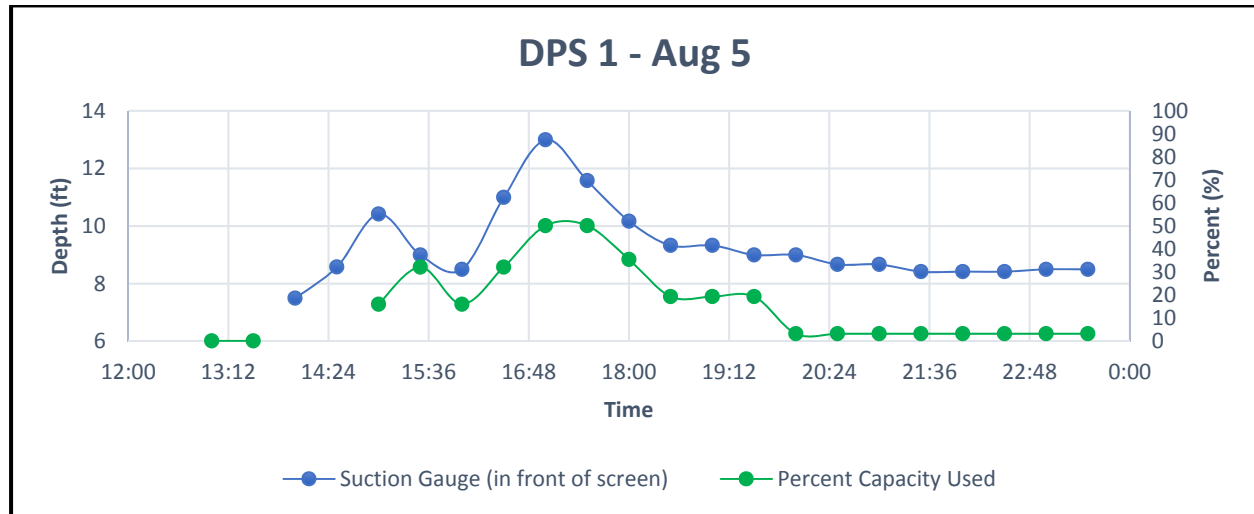
Figure 38 DPS 1 Pumping Performance August 5

Pumping commenced at 2:55 PM and continued for approximately 15 hours in the initial period. The suction basin took approximately 16 hours to clear. Maximum pumping at the station used approximately 50% of the available capacity. Pumping started approximately 30 minutes after the suction basin began to rise and was able to keep pace with the suction basin level and shown in Figure 38. Power interruptions and loss of pump load were noted in the logbook.

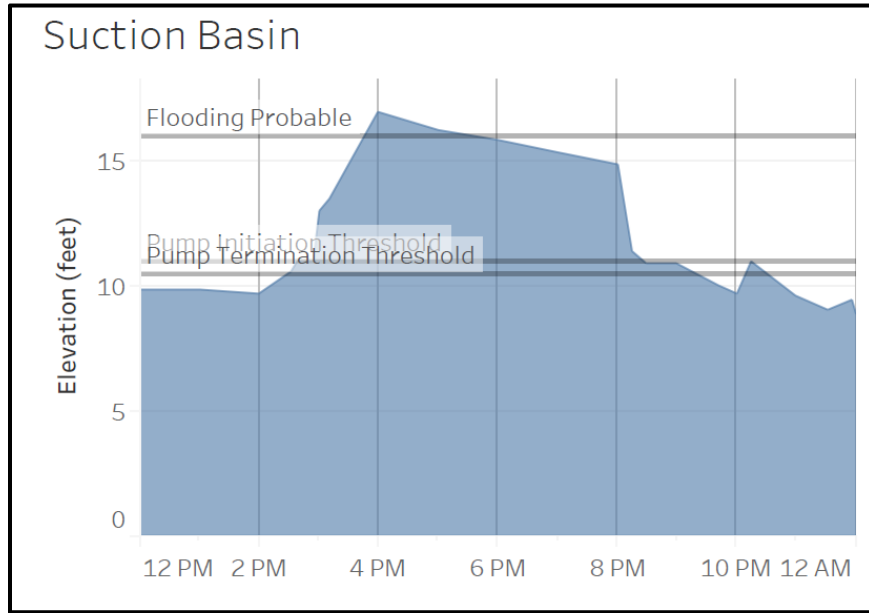
Figure 39 DPS 2 Suction Basin Levels August 5

Pumping commenced at 2:30 PM and continued for approximately 9-1/2 hours in the initial period. The suction basin took approximately 9 hours to clear initially. Suction levels rose again after midnight until 11 AM. Pumping did not restart until 7 AM. Suction basin elevations were consistent with flooding in the drainage basin as shown in Figure 39.

**Conclusion.** DPS2 functioned at current design during the event with few technical issues. However, there was significant flooding in DB 2. Despite the highest degree of pumping capacity redundancy in the S&WB drainage system, DPS 2 and system capacity is inadequate to handle intense rainfall events such as were experienced in most of DB 2 on August 5. Current pumping capacity in DPS 2 is limited by the capacity of the St. Louis Avenue Canal and possibly the Broad St. Canal. Capacity is also limited by the real-time functional capacity of outfall stations DPS 7 and DPS 3. While flooding would inevitably have occurred under such severe precipitation conditions, it is likely that flood depth and duration during the event could have been reduced if substantial improvement in DB 2 drainage pipe capacity occurred and DPS 2 discharge capacity was increased. It is also likely that flooding depth and duration would have been reduced if DPW drainage network cleaning, maintenance and repair had been accelerated.

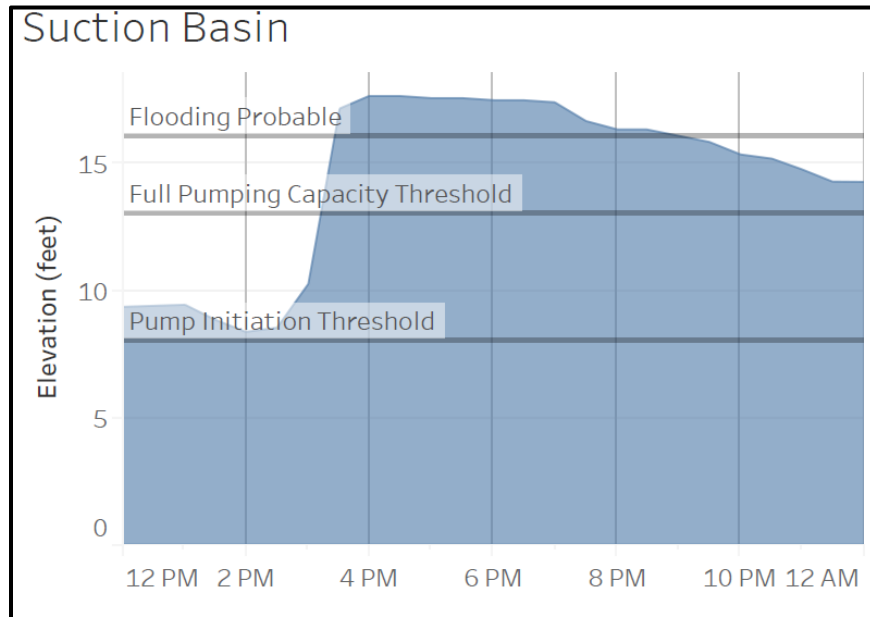
Figure 48 DPS 7 Suction Basin Levels August 5

Suction basin elevations were consistent with flooding in the drainage basin as shown in Figure 48.

**Conclusion.** DPS 7 has among the lowest pumping capacity redundancy of any drainage pumping station surpassing only the single-pump DPS 12. Together, these two stations drain approximately 5,340 acres with 145% of target drainage pumping capacity, lower than any other basins. On August 5, capacity of DPS 7 was significantly reduced such that at midnight the suction basin remained significantly elevated above pre-event level. Pumping capacity was clearly inadequate in that DPS 7 not only did not meet its target pumping capacity, but it was incapable of doing so. It is likely that significant runoff from DB 7 flowed into DB 12, which although it did not receive relatively intense rainfall, experienced significant flooding. C Pump at DPS 7 had been out of service since March 2016 and this failure of maintenance and repair management left not only DB 7 at risk for unnecessary flood impacts, but increased risk in DB 12 as well. It is also likely that flooding depth and duration would have been reduced if DPW drainage network cleaning, maintenance and repair had been accelerated.

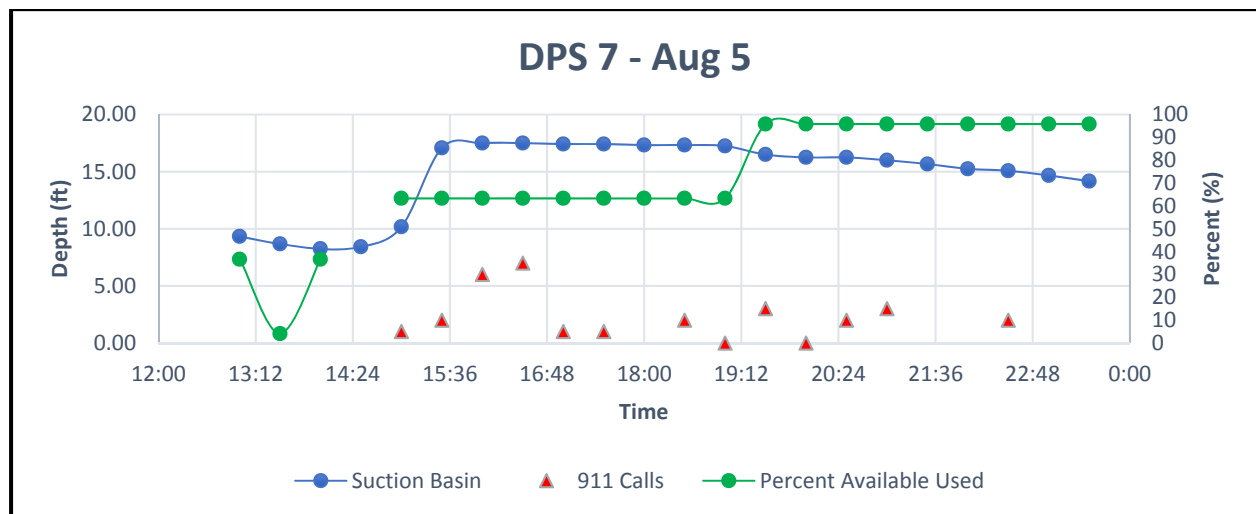
Figure 49 DPS 7 Pumping System Performance August 5 - Available

DPS 7 did not substantially meet target pumping capacity, with three large drainage pumps not in service and experienced significant flooding. Maximum pumping at the station used approximately 100% of the available capacity but only 60% of installed capacity as shown in Figure 49 and Figure 50. Three requests for pump start between 3:00-3:30 pm were denied and pump load loss was noted in the logbook.

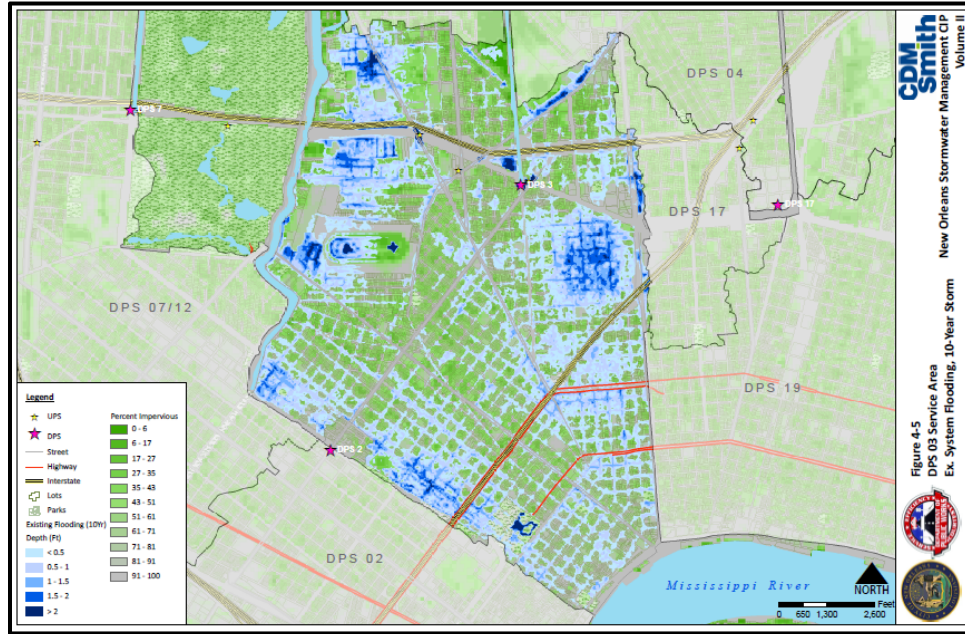
Figure 55 Predicted Flooding in DB 3 for 10-Year Storm

CDM Smith provided studies of system flooding by drainage basin for various storm recurrence intervals. These were evaluated to see water depths that would be predicted for a fully functioning, unobstructed system for storm frequencies which were observed on August 5. In drainage basin 3, where significant flooding was observed, rainfall with storm frequency equivalents between 10 and 100 years. Plots from the CDM Smith report for these frequencies are shown in these compare favorably with observed depths from the NOHSEP damage assessment shown in Figure 55 and Figure 56.
